## Building Conditions Survey

by CSI Section

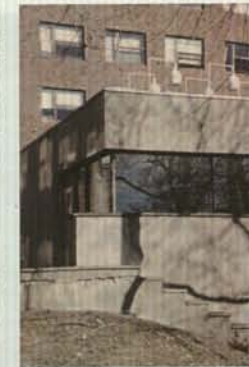
**Fig. 67** South lawn showing barbeque and eroded terrace edge

- 2.1C** It would be desirable to either screen or relocate the cars in the masters' parking area
- 2.1D** We recommend that the existing barbeque be removed and a new barbeque designed to fit into the bank that forms the west side of this lower terrace. This will augment the desirability of this terrace as an extension of Baker Dining, allow for the design of a barbeque more in keeping with what might have been Aalto's intent, and free up the southwest lawn for other activities.

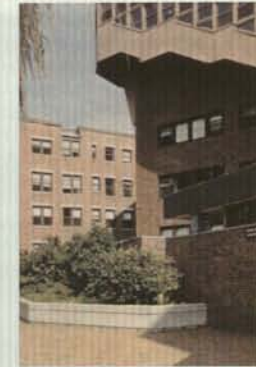
**Fig. 68** Moon Garden Pavilion with spalling concrete terrace and eroded soil.

The bluestone pavers around the Moon Garden Pavilion are natural cleff finish on the plaza and steps and are cut into strips which are set diagonally on the landing (Fig. 71). The stones themselves are in good condition, although a number have come out of alignment and will have to be reset. These are set in a bed of mortar and lightweight concrete fill, which were thoroughly saturated at the test cut locations made south of the pavilion (Figs. 72, 73). There is also evidence of water penetration beneath the waterproofing system below the lightweight slab in the form of leaks in the kitchen, dining and storage areas.

- 2.2A** All of the bluestone pavers, setting bed and waterproofing systems around the Moon Garden Pavilion should be removed, and the structural slab patched and prepared to receive the new paving system. A new membrane waterproofing system should be installed over a lightweight concrete topping slab that is contoured to drain. We recommend that a PVC membrane be considered for this application in that the seams are heat welded and do not rely on an adhesive to maintain a watertight application. The existing stones should then be reset in a soft mortar bed and pointed.

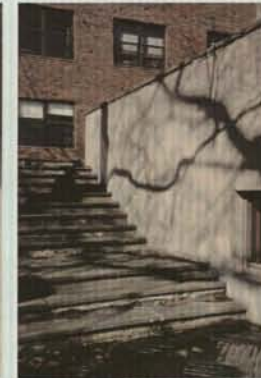
**Fig. 71** Bluestone Steps and gravel landings at Moon Garden Pavilion

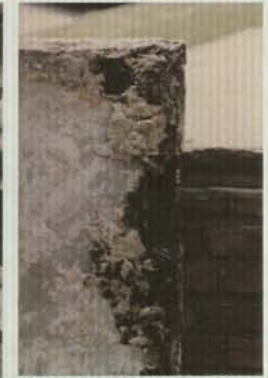
**Fig. 72** Detail of Waterproofing at underside of Moon Garden Terrace paver

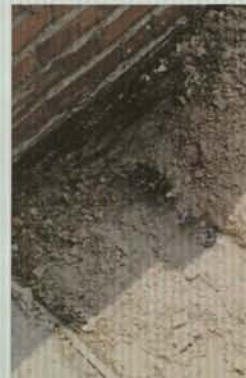
**Fig. 73** Detail of paving substrate at Moon Garden Pavilion Terrace

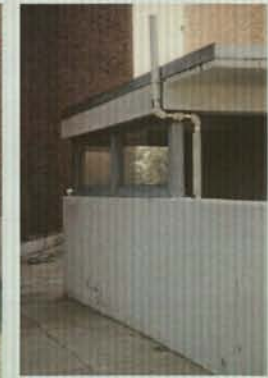
**Fig. 75** Loading Dock - East Facade

The loading dock area is sheltered by a small concrete pavilion with a wood-framed strip window. This element is, in its utilitarian guise, perhaps the purest "modern" or functionalist element of the building, and as such, it deserves the same careful restoration as the main portion of Baker House. The present condition of the building is fair; the walls (which have just been repainted) are faced with painted stucco, and the painted wood windows (also just repainted) are the only original windows, aside from the fixed units at the upper level of the Dining pavilion, in Baker House. The central window has been altered (to its detriment) by the insertion of a metal door opening to the south side of the building (Fig. 74). This door was inserted to allow the adjacent fraternity house to bring its trash through the Baker dock for deposit in the dumpster parked in the Baker loading area. The structure has a raised dock that is served by an elevator that opens through the floor. The depth of the dock and the overhead clearance are inadequate to allow larger trucks to pull up to the dock, which severely hampers its operation (Fig. 75).

- 2.3B** Consideration should be given to reworking the basement level entrance to provide better shielding from the weather and improved security. The metal door at the rear wall should be removed and the original window configuration restored. A new door should be provided hard against the west edge, to allow trash from the fraternity to be removed through the Baker dock, and not accumulate along the south and west sides of this enclosure. The dock elevator/lift should be replaced.

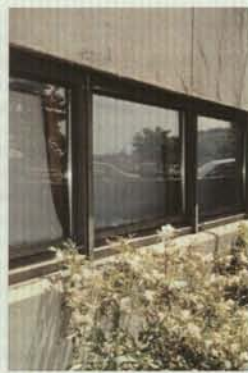
**Fig. 82** Moon Garden Pavilion limestone and aluminum replacement windows

The limestone originally had a smooth sawn finish similar to the exposed stone at the interior rear wall of the moon garden pavilion that forms the south wall of the main first floor lounge. Exposure to the weather and atmospheric pollutants has caused a sugaring effect on the surface, which yields a grainy, sand-like texture. There is evidence of water penetration behind the stone at the corners of the upper level behind the lower parapet level and at lintel veneers, where corrosion to the steel behind may be the cause of the local cracking and spalling seen in some areas (Figs. 82-84).

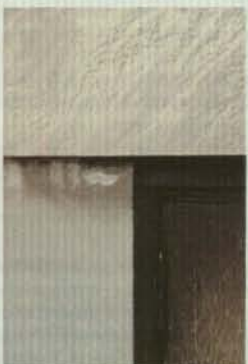
**Fig. 84** Limestone detail showing soiling and sugared stone

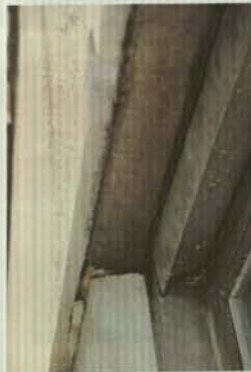
Fig. 89 Exposed lintel behind limestone at Pavilion

The only structural steel items at Baker House aside from the canopy structure at the bicycle shed are the lintels and other miscellaneous items used to frame openings and set equipment. The exterior lintels, exposed and painted at the lower face, generally appear to be in good condition; the details as to how they are set and flashed are sound for this type of construction, and they have weathered well. There is however some surface corrosion evident at some of the windows, and this is especially pronounced at the heads of the window on the upper level of the Moon Garden Pavilion. As is noted in the limestone section above, this may be due to the infiltration of water from the roof down through the wall, where it is weeped out at the lintel (Fig. 89).

- 5.1A The lintel condition should be carefully inspected as part of the condition assessment behind the limestone panel.

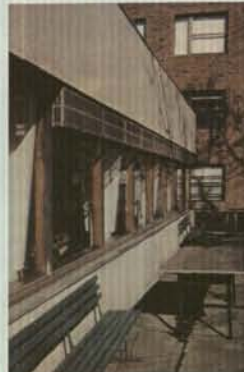
Fig. 90 Aluminum valence at upper level of Pavilion

The use of metals throughout Baker House is relatively limited. The only original exterior metal feature of note is the aluminum valence at the top of the southeast upper level window wall of the dining pavilion (Figs. 90,91). This is a fine though modest example of an element displaying Aalto's concern with the filtering of light and softening of transitions through the use of filigreed materials, and it remains in good condition. The most prominent architectural metal features are the painted steel security grates located at the basement level of the south side windows, which are not original, and will be recommended for replacement (Fig. 92). The gate to the bicycle shed is of the same design and vintage as these grills. The interior security screens on the west wing first floor rooms are of even more recent vintage. They are in good condition, and will not need to be replaced as part of this scope of work.

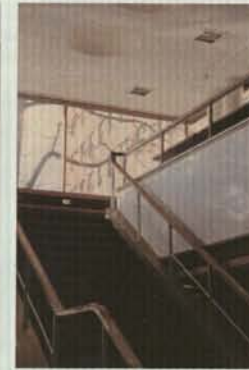
The painted steel handrail supports at the dining pavilion are original to the building but of questionable design origin, as was recounted in the history of the design evolution of the building (Fig. 93). The present assembly does not meet code in regard to the height of the top rail or the opening spacing at the guard rails. They are in fair condition; some of the intermediate steel rods are missing and the members are slightly bent, but the assembly could be easily restored.

Fig. 93 Stair/rail at interior of Pavilion

- 5.2A There is little beyond routine maintenance and repairs that will be required on the metals, short of the additional materials that will have to be added at the stairs to meet current code requirements. The exterior steel security grates and bicycle shed gate should be replaced with units more in harmony with Aalto's design as part of the optimum restoration work.
- 5.2B Two guard rails will have to be provided on the inside portions of stairs 1 and 4 to meet code height and spacing requirements. It may also be necessary to provide security gates between the lower level and the main level to help direct patrons to the outside during an emergency, by impeding their passage to the lower level.

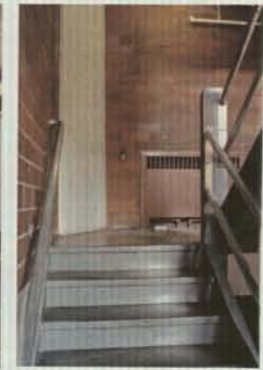
The aluminum handrails in the stairs are in worn but serviceable condition. In the main fire stairs (1 and 4) at the ends of the building, the center rails will have to be modified to meet present code requirements for guard rail height and spacing.

Fig. 94 Fire stair #1 railing

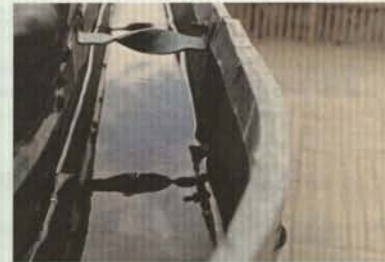
Outlets in gutter, servicing the downspouts, are too high and ponding water has been observed (Fig. 114). Downspouts have been vandalized (Fig. 115). Membrane lap seams in gutter have failed.

Fig. 114 above Ponding water in gutter Level "D"

1. Clean existing and Strip in seams w/ 6" uncured Epdm membrane.
2. Rework downspout assembly at gutter to evacuate standing water.

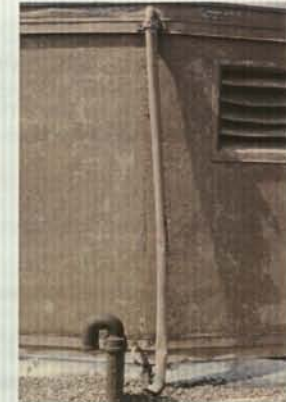
Fig. 115 right Vandalized downspouts Level "D"

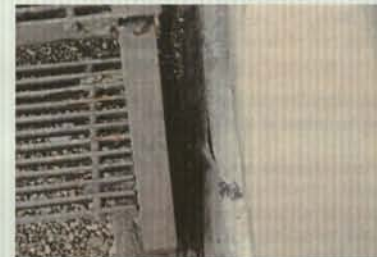
Fig. 116 Open base flashing Level "F"

Water infiltration through open flashings has caused the failure of the roofing system; we therefore recommend its removal and replacement at this time.

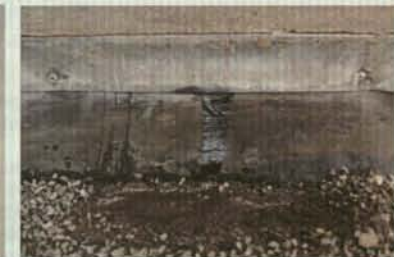
Fig. 117 Water behind base flashing Level "F"

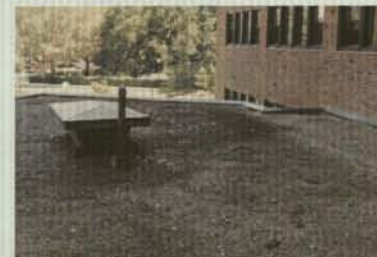
Fig. 118 Organic vegetation Level "F"

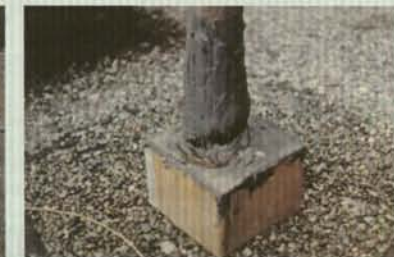
Fig. 119 Failed pitch pocket Level "F"

The pitch pocket located near the drain area has failed (Fig. 119).

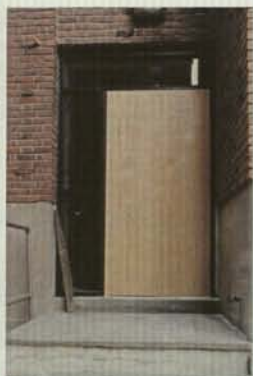
Fig. 123 New flush door at stair #4

We note that in the course of the survey the staved egress doors at the bottom of the east and west fire stairs were removed and replaced with new, solid core flush doors (Fig. 123). Although it is certainly possible that these doors were beyond the point of restoration, it must be stressed that any work performed henceforth on Baker House should be done with the intent of matching the original fabric to the greatest possible extent. This is a relatively minor issue, but it would have been worthwhile nonetheless making the effort to design replacement doors that replicate the original units in kind.

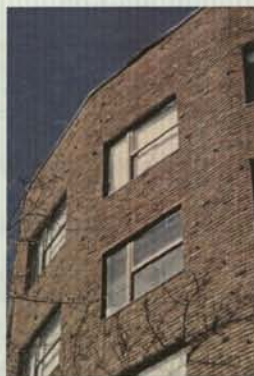
Fig. 124 Typical south facade windows (and damaged roof coping)
