## Condition Surveys: Conservators Report

Building Conservation Associates, Inc.

### Exterior Building Survey

Baker House at Massachusetts Institute of Technology in Cambridge, Massachusetts is a six-story, brick dormitory building, designed by Alvar Alto and built in 1948-49. Baker House is distinguished on the MIT campus by its curvilinear design, its "moon garden," and roof deck with panoramic views of the Boston skyline (figs. A1, A2).

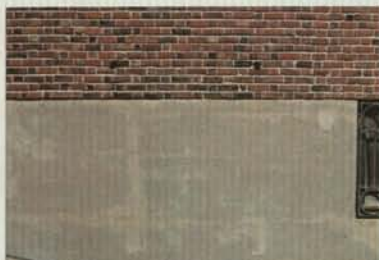
Fig. A5 Discoloration of concrete along joints of the formwork

The concrete exhibits some of the same surface discoloration found on the mortar - in some areas gray surface has turned tan in color. The pattern of this discoloration tends to be in horizontal bands, along the joints of the formwork, where the concrete surface has been parged (fig. A5).

The concrete is in very good condition. All of its surfaces appear to be sound - there is no evidence of surface spalling or cracking that would be indicative of deterioration. As noted above, there is some surface discoloration. This surface discoloration may become less distinct when the building is cleaned, but it will not be removed by cleaning.

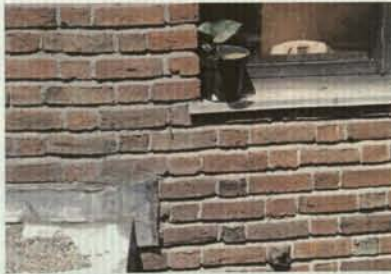
Although the exterior surface of the brick mortar ranges in color from tan to gray to dark gray, visual observation and laboratory analysis indicate that the only extensive areas of repointing are located on the south facade above the fifth floor windows. In addition, investigation revealed that the tan surface on some of the mortar was actually a surface discoloration of the original dark gray mortar that was found beneath the surface (fig. A7).

Fig. A7 above Section of south elevation exhibiting both original gray mortar (upper left section) and discolored tan mortar (lower right section)

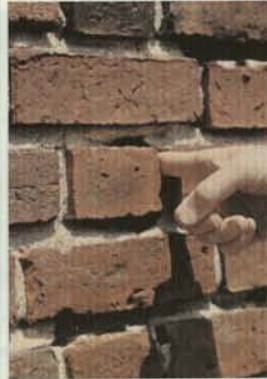
Fig. A8 right Brick mortar deterioration

The exterior brick mortar at Baker House exhibits typical levels of deterioration of a hard Portland cement mortar, aged fifty years in an urban, marine environment. The tops of the horizontal joints are eroded and the aggregate exposed. The two unusual conditions observed are surface discoloration and severe erosion. At its most severe, the mortar is deteriorated as deep as one inch from the surface of the bricks. As mentioned above, large areas of deteriorated mortar have also changed color on the surface from gray to tan. This condition greatly changes the visual appearance of the building from what was originally intended (fig. A8).

Conditions of the limestone mortar and repointing mortar suggest that both should be removed and repointed with a softer, water-tight mortar.

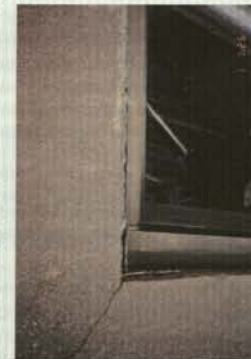
**Fig. A12** Finish coat of stucco completely abraded exposing brown coat underneath

surface causing these areas to be darker than the rest of the facade. In various other areas, most notably above the lintels of the sixth story windows, the stucco surface has been completely abraded away exposing the tan middle layer (fig. A12).

For the cracks and erosion on the north elevations, it is recommended that they be filled or patched with pigmented cement to match existing surface color. Consideration should also be given to applying a coating to replicate the darker, uniform color of the original stucco. Because the finish coat of stucco is eroded to the scratch coat in numerous locations, a coating would provide protection to this more porous stucco layer.

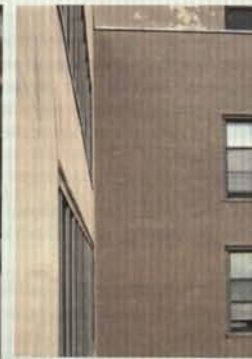
**Fig. A13** Cracking and staining of the north elevation stucco

Cracking is widespread on the stucco facades of Baker House (fig. A13). Cracks typically run vertically beginning at corners and vertical members of window frames. Water running off the corners of the sills is entering the surface of the stucco and during freeze/thaw cycles, causing it to crack. It is not known whether this condition existed prior to the installation of the new windows in the 1970s. When the windows are replaced, it is a condition that should be corrected.

Dark patches of soiling attributed to normal environmental pollutants are present in various places on the facades (fig. A13). There is also staining due to water seepage behind the stucco layers.

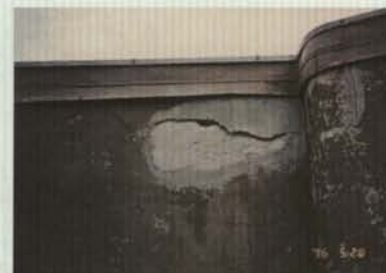
There are several large cracks on two of the roof towers (fig. A14). On penthouse #2 there is an eight foot long horizontal crack that runs across the top of the stucco facade about one foot from the cornice, in addition to surface cracking throughout the facades. On penthouse #3 there is another deep vertical crack running from the roof to about halfway down the wall.

Fig. A14 above Deep cracking and peeling paint on roof penthouse stucco

The cracks on the roof towers should be filled and any deteriorated stucco patched. The patching mortar should match the original stucco in color and texture. All of the stucco surfaces on the roof should be recoated with the original paint color.

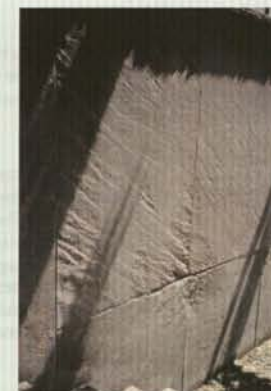
Fig. A15 right Surface erosion on the limestone sheathing, west elevation of dining hall

The limestone is generally in good condition, although many of the stone surfaces exhibit measurable surface erosion (fig. A15). This surface erosion seems to have several causes. On the north wall, where the lower roof connects the Moon Garden to the main building, in heavy rainstorms, water cascades off the lower roof down the face of the limestone. The existing roof drains are not capable of carrying the volume of water that collects off this roof and its only means of escape is down the limestone walls. Another source of moisture that is causing the limestone to erode is water entering the terrace walls through open mortar joints in the bluestone cap. Water also appears to be entering these walls at the level of the terrace's bluestone paving. Mortar samples removed from the wall below the terrace were soaked, confirming the presence of large amounts of water in the wall. As the water migrates to the surface to evaporate, it causes the surface of the limestone to erode. A final source of erosion is the

general exposure of the building on the Charles River. As discussed in the section of the report on mortar, wind driven moisture appears to cause measurable erosion on the exposed surfaces of the building.

The primary goal of the treatment recommendations for the limestone is to remove the sources of moisture that are generating its surface erosion. This includes increasing the size of the roof drains on the connector roof and possibly redesigning the roof's pitch and cornice detail. On the terrace walls, the bluestone cap should be reset and its mortar joints filled with backer rod and sealant. The bluestone paving should be reset and its perimeter joints filled with backer rod and sealant.

The areas of limestone loss should be repaired with either a cementitious patching material or limestone dutchmen. With either method of repair, the new surface should match the existing limestone surface in color and texture.

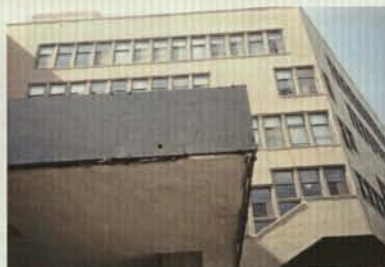
**Fig. A17 top right** Biological growth staining on limestone sheathing, south and west elevations of dining hall

In addition to general surface erosion, there are several areas of limestone that have been patched with a cementitious material colored to match the limestone. One of the larger patches has failed and there are several other small areas of loss that are in need of patching. On the south and west elevations of the dining room, where several large trees shade the wall surfaces, the limestone is stained with biological growth (fig. A17).

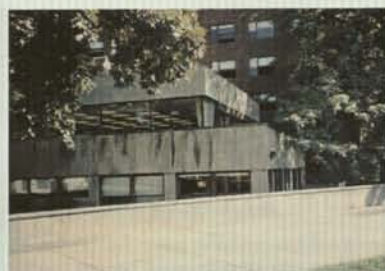
**Fig. A18 bottom right** Slate panels facing cornice of north entry roof

The surfaces of many of the slate panels are spalled. This spalling has been caused by water entering the bedding planes, which are fully exposed at the top of the panels. When the water freezes, it expands, causing the layers of slate to separate.

The is also a broken slate at the northeast corner of the entry. This slate has broken into several pieces. It appears to have been hit, possibly by a delivery truck.

The broken slate should be removed immediately as its broken pieces are poorly anchored and may fall in an area of heavy traffic. It should be replaced with a slate panel that matches the original slate panels in color, size and thickness. The existing bronze clips should be re-used to hang the new slate.

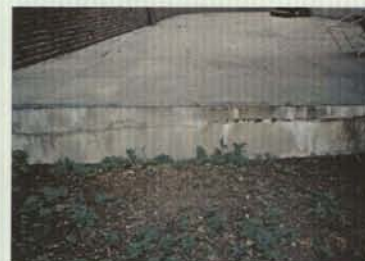
The bluestone pavers themselves are generally in good condition. They do exhibit some surface spalling which is indicative that the terraces are not draining properly. On the south terrace, their setting mortar and substructure is very deteriorated and will need replacement. The west wall of the terrace is cracked and displaced. The joints in the setting mortar have been repaired with a variety of materials and many are currently in need of repair.

**Fig. A19 above** South terrace bluestone pavers

The south terrace should be rebuilt. Before it is disassembled, it should be thoroughly documented - drawn and photographed. The bluestone pavers should be labeled and reinstalled as they were originally laid.

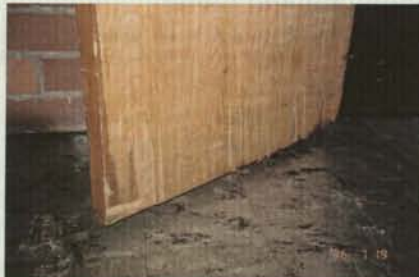
The metal doors are generally in good condition. Located in the public spaces of the building, they have been subject to heavy wear. Many of their surfaces are dented and they have been repainted numerous times. On many of the doors the painted surface is chipped and peeling. The brass hardware is very tarnished. Many of the veneers on the wooden doors are cracked, warped and in some cases have peeled off completely. This delaminated condition exists primarily at the bottom of doors (fig. A23).

Fig. A23 top right Delamination, warping, and cracking of wooden door veneer

The metal doors should be stripped of their failing paint. Documentary samples of the original paint should be preserved. The doors should then be repainted with their original light gray paint color and their brass hardware cleaned and treated with a protective coating. Options for treatment of the veneers on the wooden doors should be explored in order to make appropriate repairs.

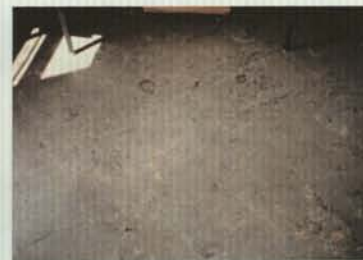
Fig. A28 Asphalt tile deterioration

The asphalt tile should be restored wherever possible in the student and recreation rooms. Areas that need replacement should be ideally patched with unworn tiles from other loca-

tions. Prior to undertaking this work, a sample of the tile should be analyzed to determine its original material composition. The replacement tiles should match the original tiles in size, color and pattern and they would be installed directly onto the concrete slab.

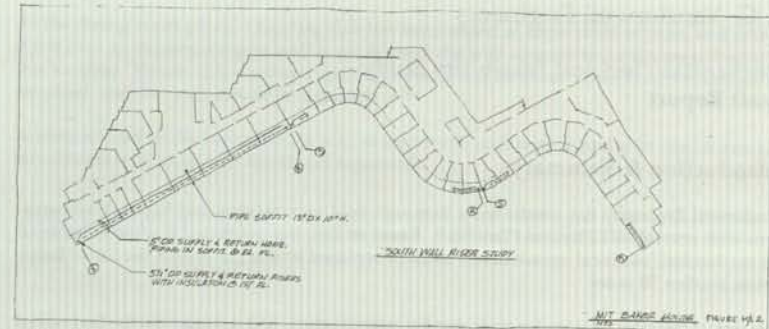
Fig. A33

The views show the existing steam and condensate piping. It is recommended that this be removed, due to its poor condition, and new hot supply and return risers be run in its place.
