## Building Conditions Survey

by CSI Section

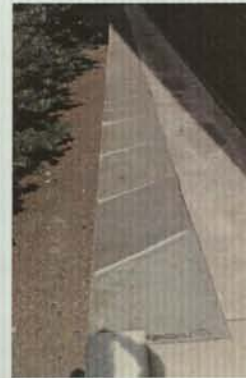
**Fig. 70** Bluestone North Terrace wall cap

The Master's Suite has a bluestone terrace on the south side, which has recently been rebuilt with a new membrane and flashing.

- 2.2B** The northeast terrace area waterproofing is over 10 years old and should probably be replaced as part of any comprehensive upgrade, especially if this area is to be landscaped.

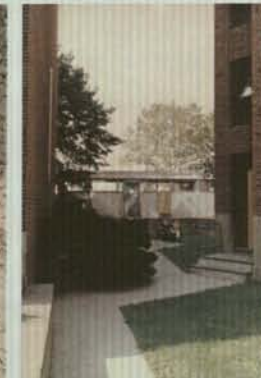
**Fig. 74** Loading Dock - South Facade

The loading dock area is sheltered by a small concrete pavilion with a wood-framed strip window. This element is, in its utilitarian guise, perhaps the purest "modern" or functionalist element of the building, and as such, it deserves the same careful restoration as the main portion of Baker House. The present condition of the building is fair; the walls (which have just been repainted) are faced with painted stucco, and the painted wood windows (also just repainted) are the only original windows, aside from the fixed units at the upper level of the Dining pavilion, in Baker House. The central window has been altered (to its detriment) by the insertion of a metal door opening to the south side of the building (Fig. 74). This door was inserted to allow the adjacent fraternity house to bring its trash through the Baker dock for deposit in the dumpster parked in the Baker loading area. The structure has a raised dock that is served by an elevator that opens through the floor. The depth of the dock and the overhead clearance are inadequate to allow larger trucks to pull up to the dock, which severely hampers its operation (Fig. 75).

- 2.3B** Consideration should be given to reworking the basement level entrance to provide better shielding from the weather and improved security. The metal door at the rear wall should be removed and the original window configuration restored. A new door should be provided hard against the west edge, to allow trash from the fraternity to be removed through the Baker dock, and not accumulate along the south and west sides of this enclosure. The dock elevator/lift should be replaced.

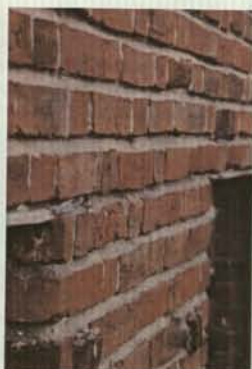
Fig. 77 West wall brick detail

The primary cladding of Baker House is a very hard, irregular, New England water-struck brick, which was fabricated (according to legend and anecdotal memory) by a small company in Northern New England or Southern Quebec. Records from Aberthaw, the original building contractor, indicate that it may be an Enos brick, although it bears a close resemblance to the Morin or Kane-Gonic bricks available today. The bricks were set without culling in a dark gray mortar, and consequently have a very irregular pattern and broad, weather-struck mortar joints\*. The brick remains in very good condition although the mortar has weathered, severely in places, and has bleached to a beige color (Fig. 77, 78). At the west end of the north wall, adjacent to the loading dock there is an area of approximately 100 square feet where the brick has been se-

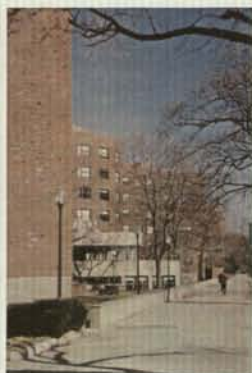
**Fig. 80** Limestone Moon Garden Pavilion from Southwest

Limestone is used as the cladding material for the moon garden (dining) pavilion, which Aalto perceived as being the white, ceremonial element or "jewel" of the complex, set off against the dark back-drop of the serpentine brick dormitory block (Fig. 80). The limestone is of unknown provenance, although its source is probably one of the major Indiana quarries. It is used solely as a veneer cladding material, and is not load-bearing. The jointing, which has an interlocking pattern on the blank sides of the building and a grid pattern on the glazed elevations; and the detailing of the stone relative to the ribbon window elements, where the lintel stones are projected slightly beyond the stones at the normative plane of the wall, display Aalto's concern with the subtleties of the iconographic representation of a particular material, and how the ensemble of components is meant to interact in a harmonious fashion (Fig. 81).

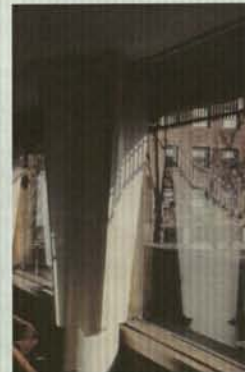
Fig. 87 Aluminum valence and column w/steel fins in lounge #1 (basket/trellis wood trim has been removed)

The use of metals throughout Baker House is relatively limited. The only original exterior metal feature of note is the aluminum valence at the top of the southeast upper level window wall of the dining pavilion (Figs. 90,91). This is a fine though modest example of an element displaying Aalto's concern with the filtering of light and softening of transitions through the use of filigreed materials, and it remains in good condition. The most prominent architectural metal features are the painted steel security grates located at the basement level of the south side windows, which are not original, and will be recommended for replacement (Fig. 92). The gate to the bicycle shed is of the same design and vintage as these grills. The interior security screens on the west wing first floor rooms are of even more recent vintage. They are in good condition, and will not need to be replaced as part of this scope of work.

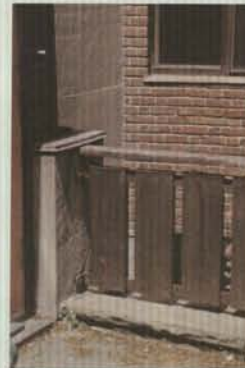
Fig. 95 Wood railing at North side of Pavilion

There are no exterior wood elements (aside from the remaining wood windows and doors, which are covered under Division 8) that remain from the original building, with the exception of the wood railing on the East side of the Moon Garden Pavilion (Fig. 95). This element, which is designed in the same motif as the radiator covers in the lounges (Fig. 96), originally had a clear finish, which has been painted over to match the bronze anodized windows. The roof deck and garden screen walls and gate at the Master's Suite entrance have all been added within the last 15-20 years. They are both in weathered but sound condition. Further discussion of the roof deck is to be found under Division 7 of this section of the report, and in the design recommendations.

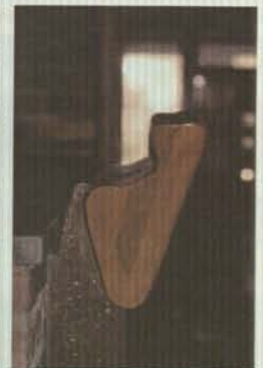
Fig. 97 Railing at west side of entry

The major remaining millwork elements are the handrails at the west side of the entry lobby and the Moon Garden Room (Figs. 97, 98), the counters at the entry lobby and snack bar, the paneling and booths along the corridors and the enclosure/benches over the heating elements in the lounges (Fig. 99). These are all of birch except for the handrails which are (according to the working drawings) of Brazilian pine. All of these have a high gloss clear natural finish. The condition of these elements varies from excellent, at the main lobby west rail, to poor, at the enclosures around the radiation in the lounges, with the majority of the millwork being in fair but restorable condition.

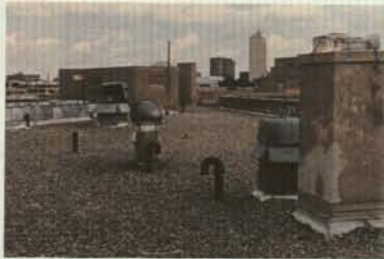
Fig. 108 Roof penetrations Level "A"

Penetrations and roof top equipment are predominately located at the west side of this roof level (Fig. 108).

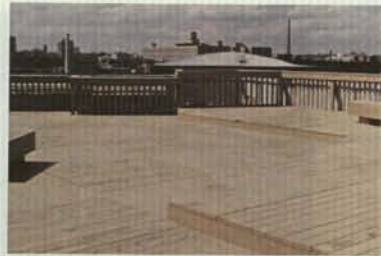
Fig. 109 Tiered deck Level "A"

A painted wood tiered deck has been installed between Roof Levels "C" & "D" (Fig. 109). Support posts rest directly on concrete pavers (Fig. 110).

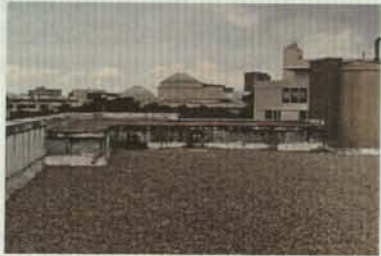
Fig. 111 above Decking supports Level "A"

Roof Level "A1" is a built-up roofing system made up of pea stone gravel, 7 plies of roofing felt w/ interply moppings of coal tar pitch and a base sheet mopped to a concrete plank substrate (Fig. 111), (Test Cut # 2).

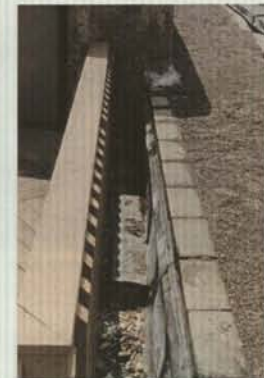
Fig. 113 right Edge condition Level "A2"

Roof Level "A2" has a similar make-up to Roof Level "A1" with the exception that the original drawings show light weight concrete sloping to the edge of the penthouse for positive water flow to drain (Fig. 113).

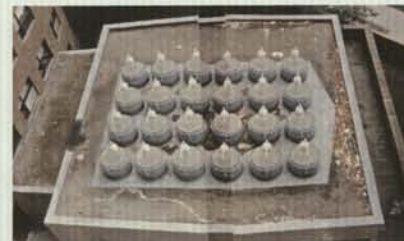
Fig. 120 Level "G" (left), Roof level "H"

Roof Level "H" at the dining pavilion has a built-up roofing system installed at the perimeter of the roof and lead coated flat seam copper roofing installed at the base of the central skylights (Fig. 120). The substrate, as shown on the original drawings, is a 8" structural concrete slab. The pavilion roof is dotted with a grid of 24 circular skylights of the type used by Aalto throughout his career, from the Turun Sanomat Building and Viipuri Library in the 1920s, to the end of his career. They are sheathed on the outside in lead coated copper, and inside in painted sheetmetal. The glass is an obscure slanted circular light, over which is mounted an Aalto designed light fixture. They have had a history of leaks throughout the life of the building.

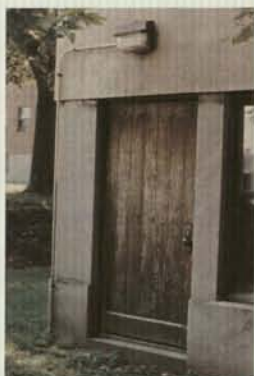
Fig. 122 Staved oak door at Pavilion lower level

The Baker House exterior wood doors are of two primary types. One is the staved oak doors found at egress points around the building, such as the lower level of the Moon Garden Pavilion, in the Master's Suite and the fire stairs (Fig. 122). The second are the birch veneered glazed doors found at the upper level of the moon garden room and the main building entry. The entry doors are the original units, one of which has recently been restored by the company presently engaged in the furniture restoration project. We recommend that the other three doors be restored to the same standard.
