## Condition Surveys: Conservators Report

Building Conservation Associates, Inc.

### Exterior Building Survey

Baker House at Massachusetts Institute of Technology in Cambridge, Massachusetts is a six-story, brick dormitory building, designed by Alvar Alto and built in 1948-49. Baker House is distinguished on the MIT campus by its curvilinear design, its "moon garden," and roof deck with panoramic views of the Boston skyline (figs. A1, A2).

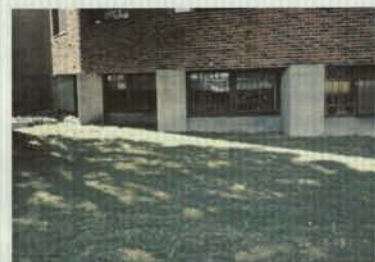
Fig. A3 Concrete at the building's foundation

The exterior concrete is located at the building's foundation, in the triangular-shaped pier that supports the north entry and on the bracket that supports the east end of the north elevation stairs (figs. A3, A4). The concrete is cast-in-place, the horizontal lines of the formwork are still visible on many of the concrete surfaces. The concrete is light gray in color and has a relatively smooth finish. The surface of the concrete appears to have been smoothed with a concrete parging - not a continuous surface, but rather a parging to fill recesses caused by the placement of the formwork. This parging was applied at the time of construction because it runs under the foundation through-wall flashing.

The concrete is in very good condition. All of its surfaces appear to be sound - there is no evidence of surface spalling or cracking that would be indicative of deterioration. As noted above, there is some surface discoloration. This surface discoloration may become less distinct when the building is cleaned, but it will not be removed by cleaning.

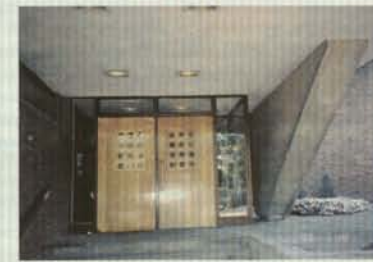
Fig. A4 Triangular-shaped pier supporting north entry

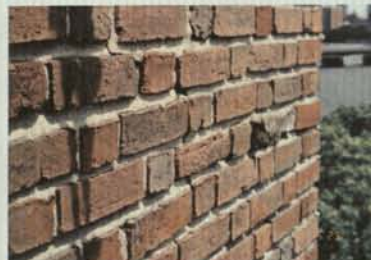
Fig. A6 Brick mortar joints

The exterior brick mortar at Baker House exhibits typical levels of deterioration of a hard Portland cement mortar, aged fifty years in an urban, marine environment. The tops of the horizontal joints are eroded and the aggregate exposed. The two unusual conditions observed are surface discoloration and severe erosion. At its most severe, the mortar is deteriorated as deep as one inch from the surface of the bricks. As mentioned above, large areas of deteriorated mortar have also changed color on the surface from gray to tan. This condition greatly changes the visual appearance of the building from what was originally intended (fig. A8).

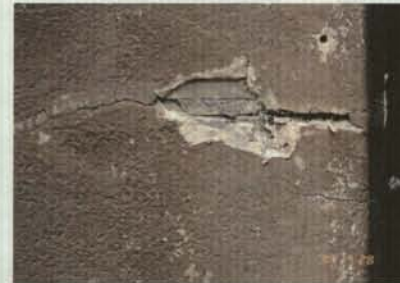
Fig. A9 right North elevation stucco system

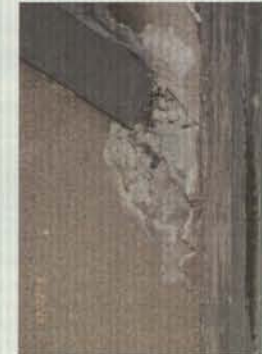
Fig. A10 above Roof penthouse stucco system

On the roof penthouses, laboratory analysis indicates that the binder:aggregate ratio is 1:3.5. Aggregate is well graded with the majority of particles in the 0.5 to 1 mm range. Under microscopic investigation, angular to sub-angular particles of quartz (milky and smoky), mica, and yellow fluorite were observed.

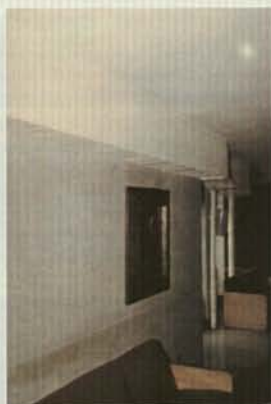
The surface of the limestone was originally quite smooth - it appears to have matched the limestone panels located on the west wall of the main lounge (fig. A16). It was originally laid and pointed with a relatively soft light gray mortar. All of the exterior mortar joints have been repointed with a hard and brittle gray Portland cement mortar, however, fragments of the original mortar survive behind the repointing mortar.

**Fig. A16 above** West wall main lounge clad with limestone

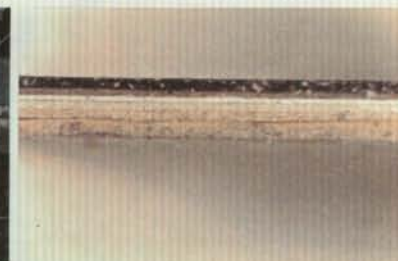
**Fig. A20 top right** Sample paint stratigraphy for roof elements (substrate at bottom followed by subsequent layers of paint taken from door hinge)

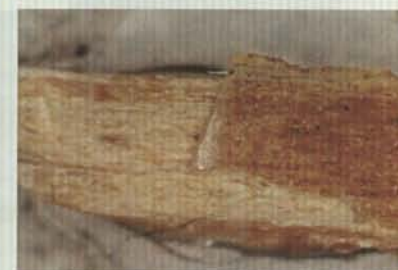
**Fig. A21 right** Varnish exhibited on sample from dining hall window casing

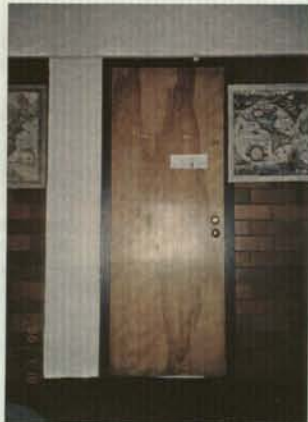
Fig. A22 above Wooden dormitory room door

The metal doors should be stripped of their failing paint. Documentary samples of the original paint should be preserved. The doors should then be repainted with their original light gray paint color and their brass hardware cleaned and treated with a protective coating. Options for treatment of the veneers on the wooden doors should be explored in order to make appropriate repairs.

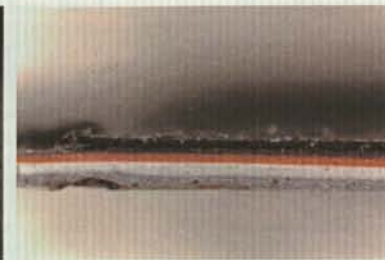
Fig. A29 Paint stratigraphy from door casing in first floor hall (substrate at bottom of photo)

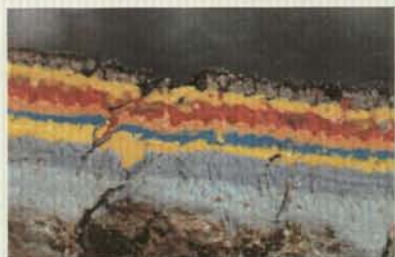
**Fig. A30** Paint stratigraphy from door casing in Room 320 (substrate at bottom of photo)

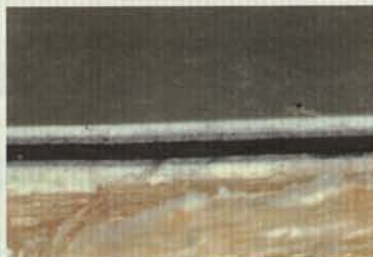
**Fig. A31** Paint stratigraphy from door casing in Room 206 (substrate at bottom of photo)

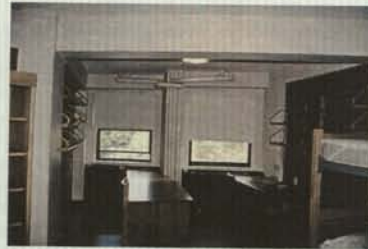
Fig. A32 Existing Heating Student Rooms

The views show the existing steam and condensate piping. It is recommended that this be removed, due to its poor condition, and new hot supply and return risers be run in its place.

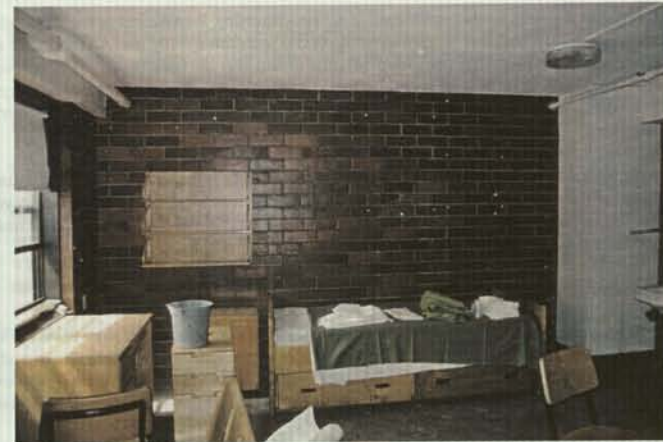
Fig. A40 Electrical & Teledata Rewiring Student Rooms

The view above shows the party wall with the corridor wall at right. The wooden plumbing chase designed by Aalto is in the right hand corner, and one of the lavs it was designed to serve is also visible. The energy conserving disc shape light fixture was substituted by MIT for Aalto's incandescent bowl fixture, in a different location than the original. MIT-installed surface metal raceway running from the lighting fixture to a smoke detector is also visible, as is a lateral section of sprinkler piping, also retrofitted by MIT, which penetrates the party wall.
